BULGARIAN FIGHTER COLOURS 1919–1948

Vol. 1

Rainbow No 9136

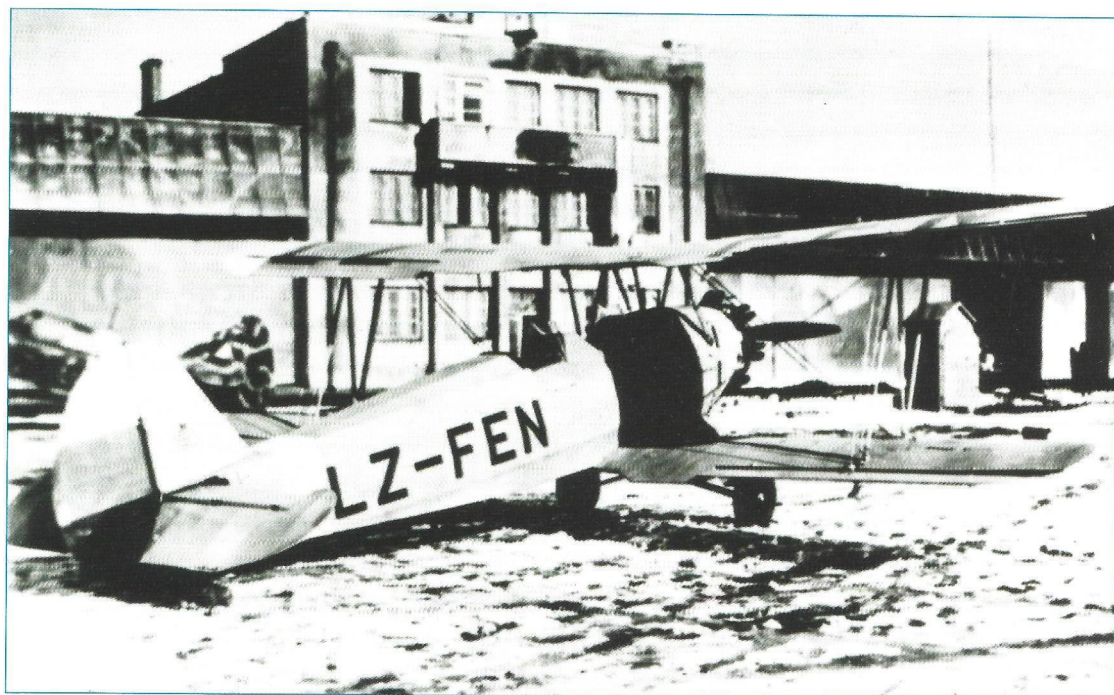
49. Following Bulgaria's about face of 9 September 1944, when it left the Axis camp and joined the Allies, Bulgarian warplanes had to co-operate with the Soviet air force (VVS). This change required new identification for Bulgarian aircraft, that would identify them as 'Allies' (to the Soviets, that is). Accordingly, white identification colour was applied on Bulgarian airplanes, starting on 20 September 1944. The white colour was applied on the tips of both the lower and upper wing, as well as in the form of a mid or rear fuselage band. The spinner should have been painted white as well (where it was the case). At the same time, all yellow paint had to be removed. This new identification colour is shown on the depicted Focke-Wulf Fw 44j, LZ-FEN, Werknummer 2743, NN 39/7021, photographed in mid-September 1944. This particular photo was chosen by the Author to also show a strangely painted Dewoitine D.520, seen in the background at left (which sports a wide, white mid-fuselage band just aft of the cockpit, under the antenna mast). That particular camouflage scheme was undoubtedly of Bulgarian origin.

viets, that is). For the 5th and 17th Air Armies of the VVS fighting on the southern (left) flank of the front (covering Rumania and Bulgaria), the white colour was generally used as identification. This colour was introduced on aircraft of the Rumanian air force as well, starting from early September. The same had to apply to now 'friendly' Bulgarian airplanes, too. [photo 49]

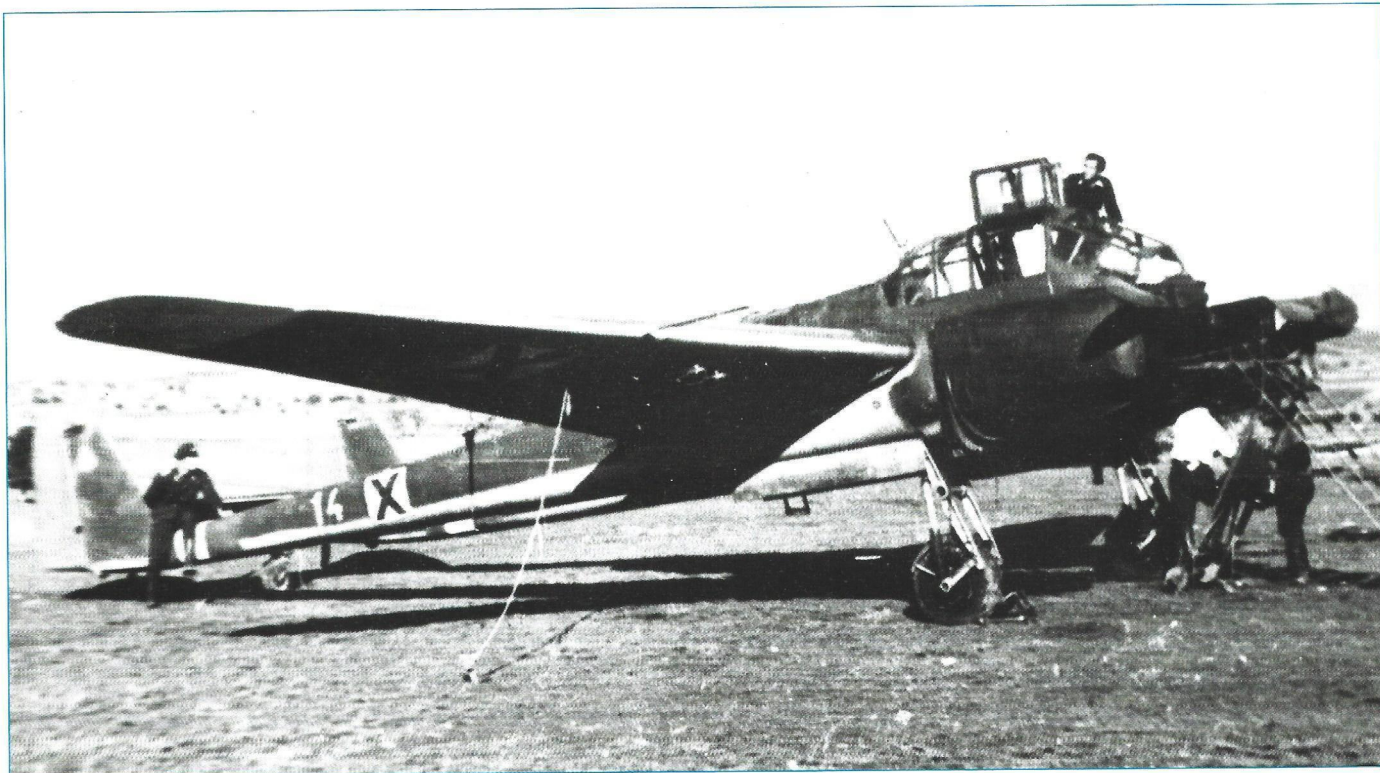
50. As noted in the previous photo legend, yellow 'Axis' recognition colour ought to be removed from Bulgarian aircraft following the 'about face' of September 1944. However, in practice there were many exceptions to the rule when it comes to Bulgarian markings and codes. One is the case of the depicted Fw 189A-2 Oko ('Eye'), NN 14/7106, 'White 14', where the yellow colour was overpainted on the lower wingtip and rear fuselage; however, strangely, it was left untouched on the rudder. The spinners were not painted white, either.

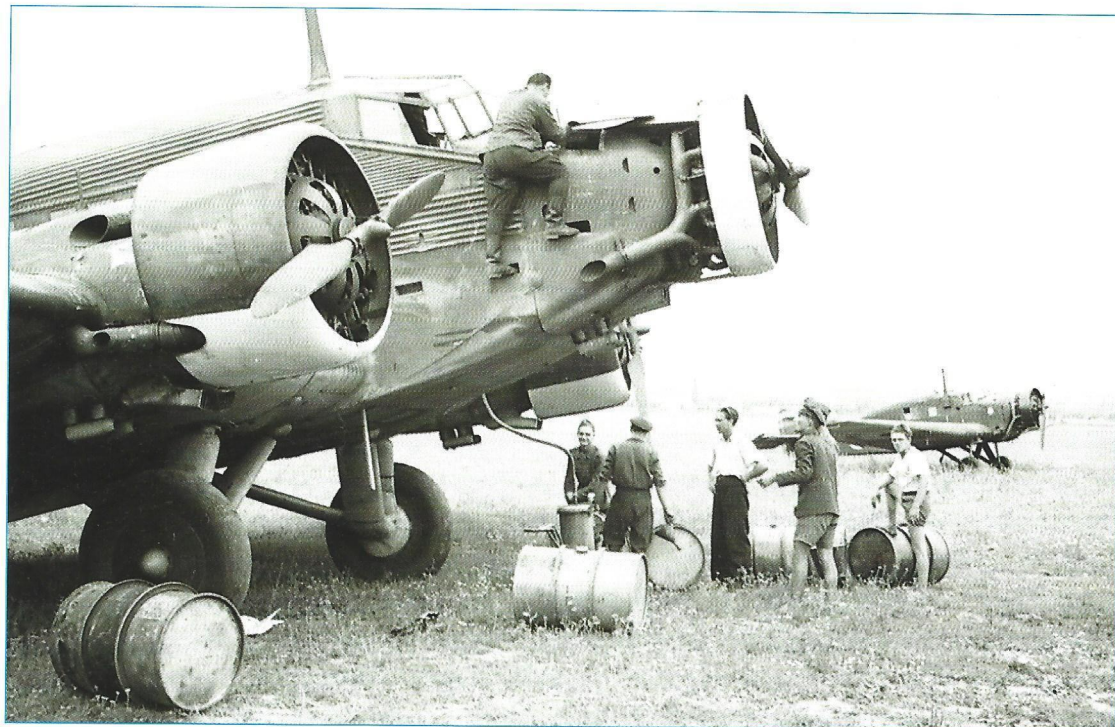
51. Following a 'friendly fire' incident that occurred in March 1945, when Soviet fighters shot down a Bulgarian Do 17 bomber over Southern Hungary, Bulgarian airmen suggested the aircraft flying on the Sofia (Bulgaria)-Zemun (Yugoslavia)-Pécs (Hungary) route and back to be identified with a large orange-red dot, surrounded by a 10-cm wide white ring, instead of the Axis-style black cross. This experimental marking was applied only on a couple of aircraft. On this official photograph, taken at Pécs airfield on 1 June 1945, a Junkers Ju W34, captured from the Germans, can be seen in the background.

What is most interesting is the Bulgarian tricolour, applied horizontally on the tail surface, as well as a roundel type marking barely visible on fuselage side and underwing surface. This could very well be the temporary marking introduced to avoid 'friendly fire' incidents with Soviet fighters. Curiously, the engine's NACA ring was not painted white, as was the Junkers Ju 52/3m's in the foreground. The wingtips don't appear to sport the white recognition colour, either. Loss lists mention a Ju W34 Därvenitsa (Bedbug) crashed on Pécs airfield, on 1 July 1945, killing all aboard. Chances are, it was this particular aircraft that was subject of the described deadly accident.

The subsequent investigation by the joint Bulgarian-Soviet committee following this grave incident revealed that the Soviet pilots fired upon the Bulgarian machine, identified with the 'St. Andrew's Cross', believing that a 'fascist' aircraft was in their gunsights, despite the clearly displayed white identification colour. Therefore, as an interim measure, the Bulgarian airmen suggested the aircraft flying on the Sofia (Bulgaria)-Zemun (Yugoslavia)-Pécs (Hungary) route and back be identified, instead of the black cross, with a large orange-red dot, surrounded by a 10-cm wide white ring. The air force headquarters in Sofia initially accepted the proposal. However, after this experimental marking was reportedly applied on a couple of aircraft in the rather primitive conditions existing on Pécs airfield [photo 51], came a new

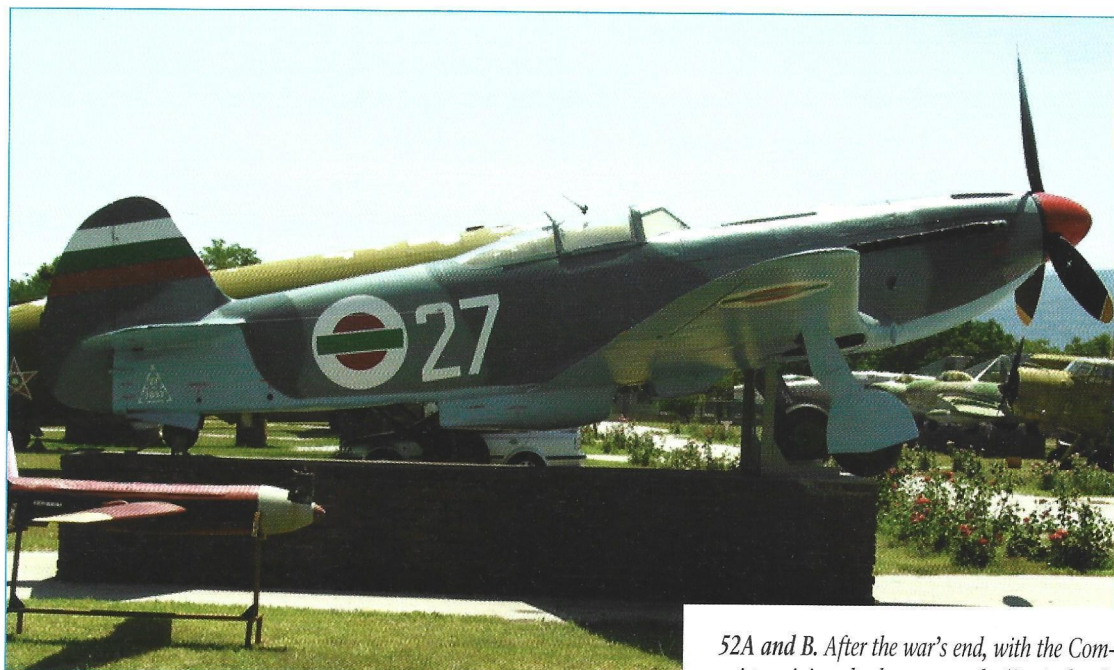
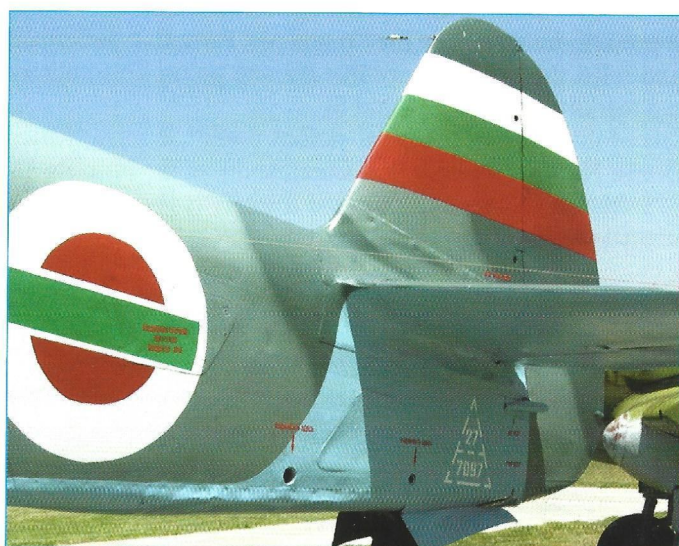
52A and B. After the war's end, with the Communists gaining absolute power, the 'St. Andrew's Cross' marking – associated by them with the 'fascist' era – was replaced with a new military marking, reflecting the changed times. The new roundel could be also identified with the Cyrillic letters OF (ОФ), short for Отечествон фронт (i.e., Otechestven Front), or Fatherland Front – a coalition of leftist powers, dominated by the Communist Party. Despite different sources giving the date of the marking change at various times, it actually happened officially on 4 October 1945. Along with the roundels, the tail surface received a tricolour band spanning it horizontally. The 'OF' marking is nicely seen on this recently restored Yak-9P, prob. constr. no. 0267, NN 27/7097, 'White 27', exhibited at the Bulgarian aviation museum at Krumovo, near Plovdiv. (photos V. Petrov)

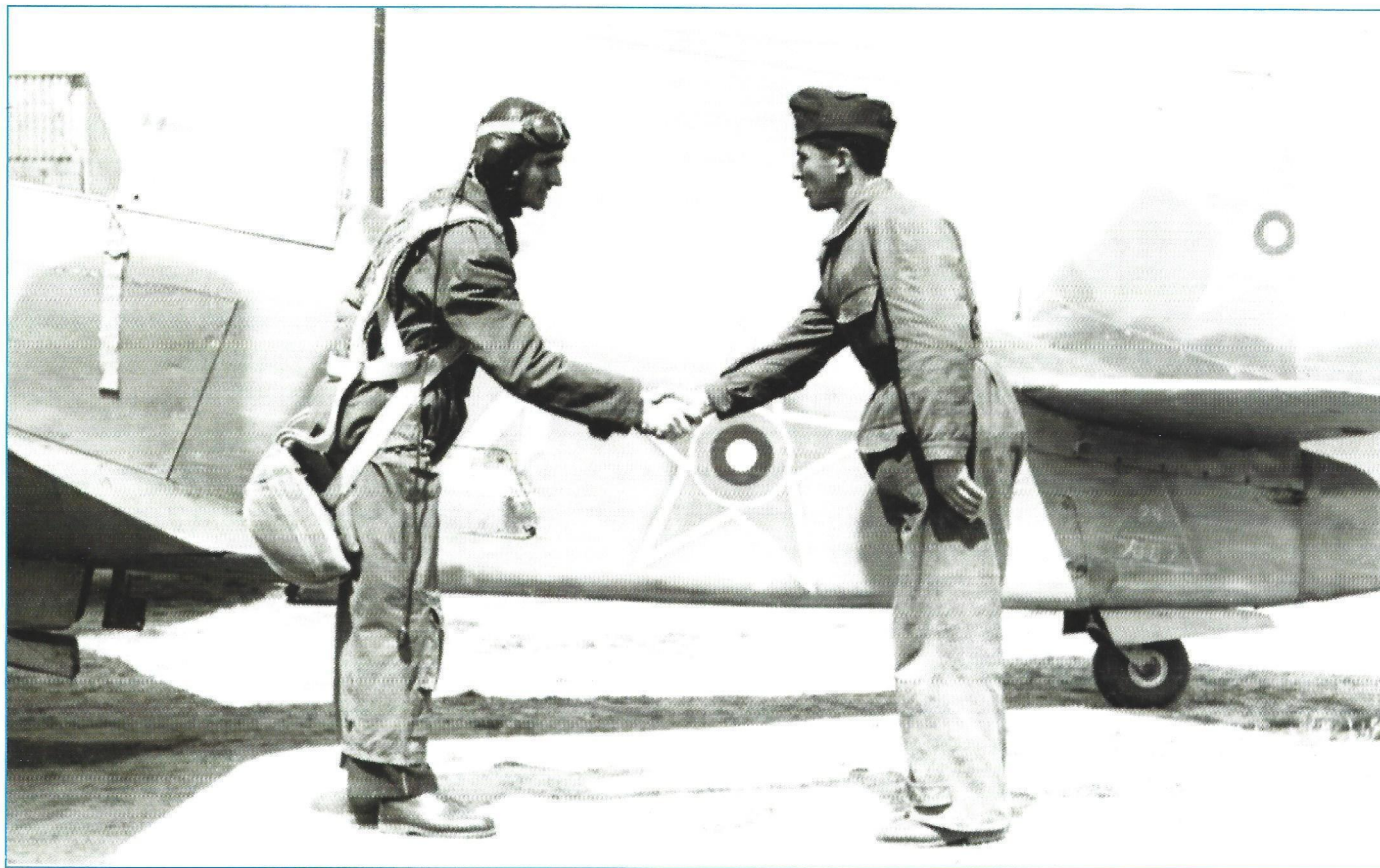
53. The OF-style roundel gave way sometime in 1951 to the red star type marking. It consisted of a white dot in centre, surrounded by green and red rings (Bulgaria's national colours). The Bulgarian cockade was edged by a thin white circle. This was inscribed into the centre of a five-point red star, edged in white. This style of pro-Soviet marking was typical of those Soviet satellite countries that were once part of the Axis allies (Rumania, Hungary, Bulgaria). The NN written in triangle remained unchanged. The depicted Yak-9M, NN 29/7087, shows this new marking. Notice the 'board number' on the fuselage (4, or ending in 4), is not identical any more with the aircraft's individual number of the NN (shown in the top area of the triangle).

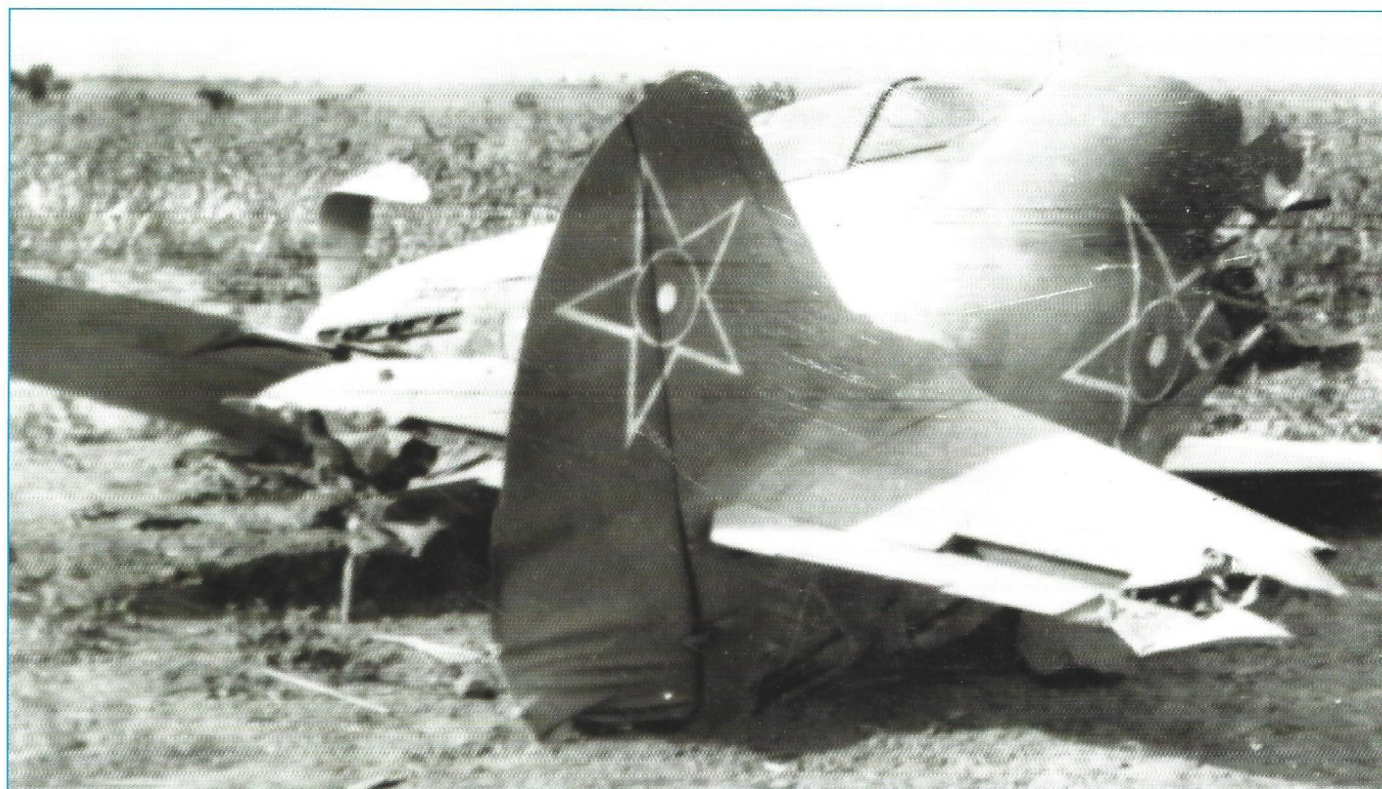
54. The crashed aircraft is Yak-9, construction number 4415339, NN 101/7087, piloted by an aviatrix, лейтенант Мария Атанасова (Lieutenant Mariya Atanasova), who hit the ground at Polikraishte, near Gorna Oryahovitsa, on 22.08.1952. The aircraft broke in two, but luckily she escaped unhurt. The new, Communist inspired military marking is clearly seen on the airframe.

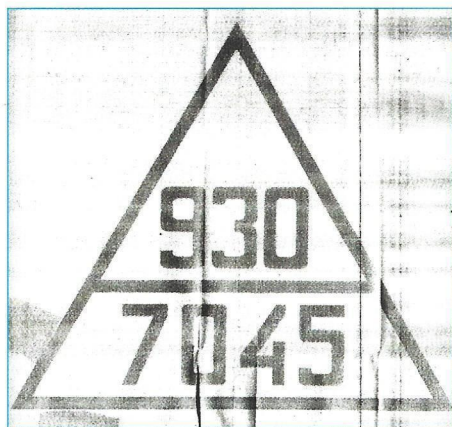
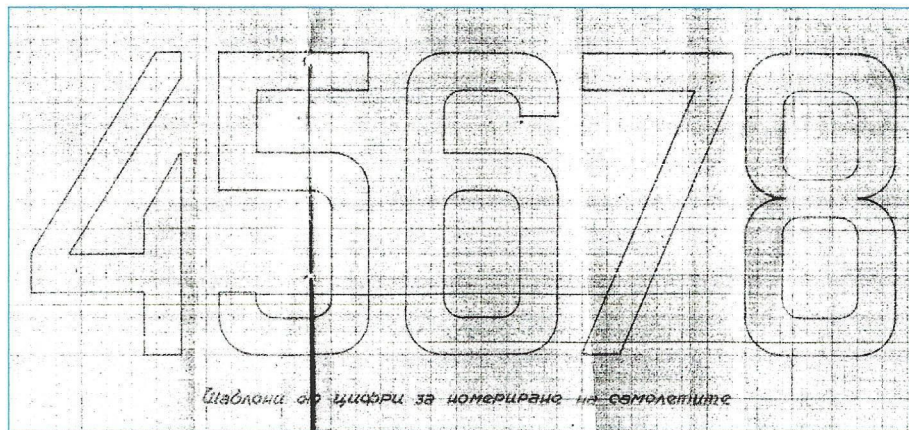
55A and B. Photocopied annexes to the order referring to the new markings and codes to be used on aircraft, dated 4.10.1945, point #3: "Triangle with the nomenclature and the registration number". The hand-written sentence on the bottom reads: "Stencils/patterns of numerals/cyphers for numbering of aircraft".

1, *National marking* (in original 'boen znak', or 'combat insignia')

The new marking consists of two concentric circles: a red [dot] of 50 cm diameter [centre] and a white [circle] of 80 cm diameter [around it]. These circles are crossed by a horizontal green stripe [bar] of 80x15 cm size. This green stripe [bar] has to have a 1 cm wide white border. The marking has to be located on both sides of the fuselage, in place of the old insignia of the “old material” [i.e., the older aircraft types, in service during wartime], or in place of the insignia of the “new material” [i.e., reference to the newly delivered Soviet aircraft types, where they should replace the Red Stars]. If it is impossible to apply the marking with the prescribed diameter, the white circle can have 75 cm diameter, while the red circle [dot] has to stay 50 cm diameter. The green stripe [bar] in this case can be 75x15 cm. When the “old material” [see note above] has to be repainted in the future, the marking should be relocated back, to the location [of the marking] on the “new material” [see note above]. The national marking has to be applied also on the [lower] surface of the wing, in the location of the old marking, with the diameter of 60 cm (red dot in centre) and 90 cm (white circle around it)¹. The green stripe [bar] has to be 90x15 cm. The markings should not be applied on the upper surface of the wing.

29 Excerpt from the following original document, dated 4.10.1945, called: Заповед относно знаците на самолетите (Order regarding signs on aircraft), Point No. 3: За триъгълника с номенклатурния и регистрационния номер (For the triangle with the nomenclature and the registration number).

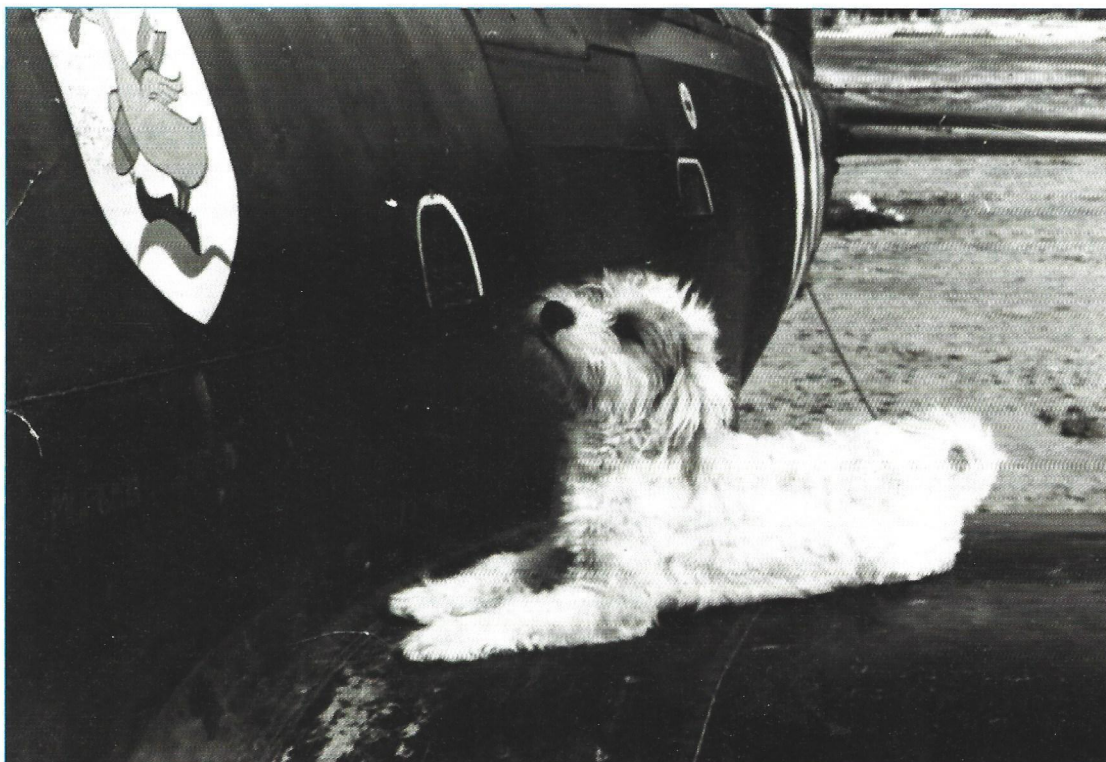
56. Unlike other Axis (and Allies) aviation units, unit emblems were not of widespread usage in the Bulgarian air force. Only very few combat units had their own emblems. This included all aircraft of the seaplane Yato (squadron). Depicted is the top seaplane type employed by the Bulgarians, the Arado Ar 196A-3, with a squadron emblem consisting of a quacking duck wearing clogs (wooden shoes), with a bomb under its right wing (similar to the Luftwaffe’s 3./SAGr. 125 emblem, based at Varna until mid-February 1944). Notice the yellow (?) service stencils on the fuselage and wing leading edge are in Bulgarian.

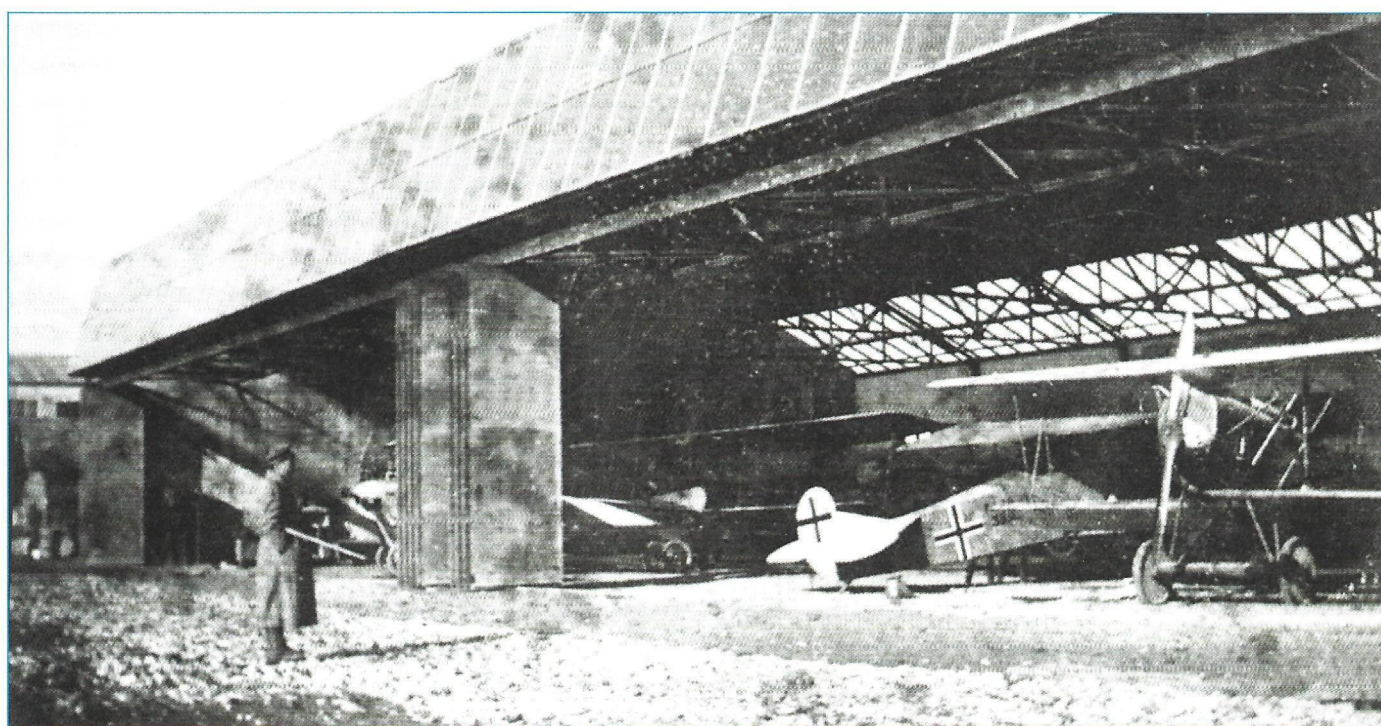
The object of inspection by Captain Chatterley was Fokker D.VII, 5355/18 – “the newest type of scout airplane”, which “had been used very little, if at all” – and particularly its armament. This biplane is seen here parked in front of the main hangar. Notice the propeller-less Nieuport Nie.24C1, at right, and the Albatros C.III, sporting a white cross on its fuselage, in the hangar.

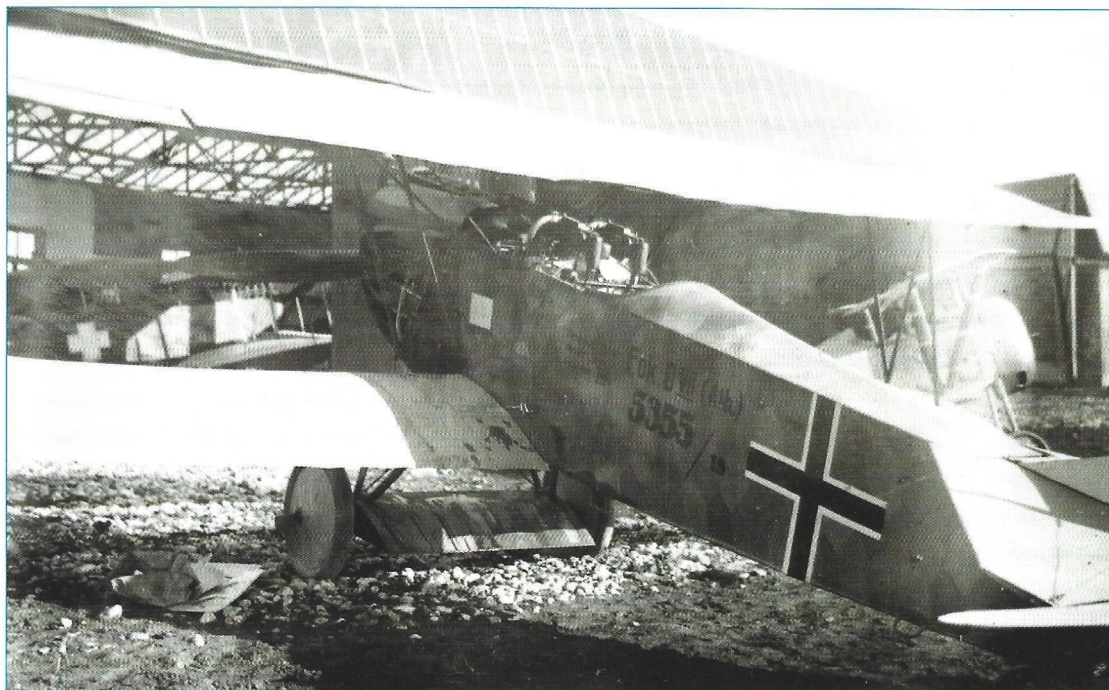
The armament of the Fokker D.VII consisted of a pair of Spandau fixed machine guns, firing through the propeller arc. 500 rounds were carried by each gun.

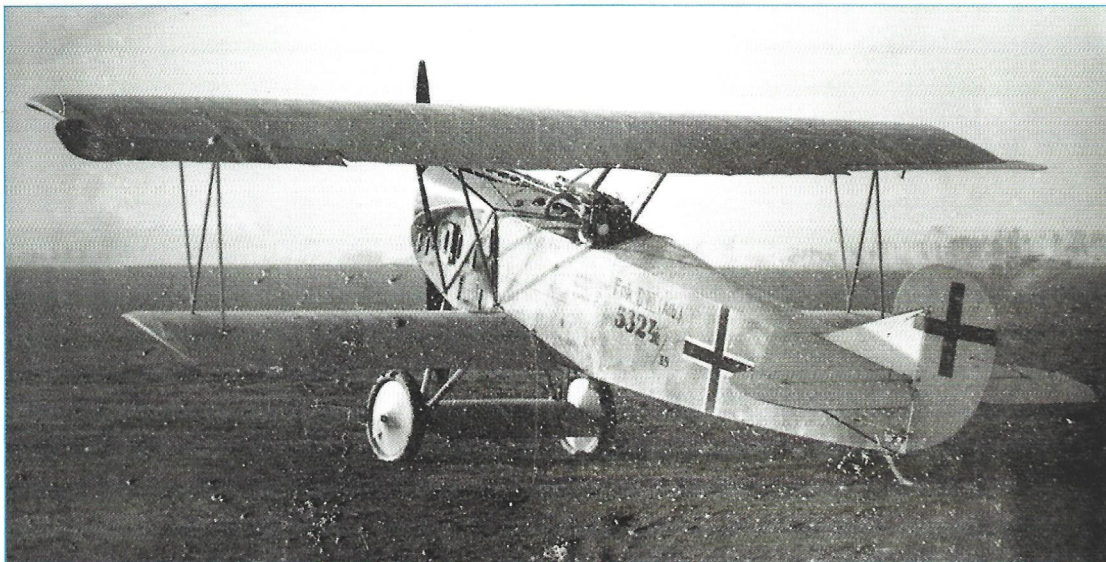
Three views of one of the main protagonists of Captain Wells' inspection, Fokker D.VII, 5324/18. The detailed description of this particular aircraft, including camouflage and markings, can be read in the Annex.

Camouflage: all fabric parts of machine, except rudder and fin, are covered with dyed camouflage fabric, the pattern being printed on the fabric, and consisting of rectangular and 5&6 sided figures of an average diagonal measurement of about 9" of various colours. Those on the sides and upper surfaces are fairly subdued, mostly heliotrope, light and dark green, dark blue and light brown. On the under surfaces more vivid colours are employed, consisting of light Prussian blue, pale crimson, buttercup yellow, and light green. The rudder and fin are painted white. Fabric of fairly good quality, insufficiently doped. (...) Very sensitive machine and difficult to land, not tiring to fly. Range of vision very fair. Strongly constructed [presumably the opinion of Bulgarian pilots, D.B.]. Armament consists of 2 Spandau guns, fixed, firing through the propeller, flexible drive, interrupter gears, driven off engine camshaft. 1918 type, starboard No. 7625, port No. 7611. 1000 rounds of ammunition, 500 each gun. 1 in 4 tracer.

Markings: Lower plane, rear spar dated 20/8/18, front spar dated ditto. Top plane dated 24/8/18."

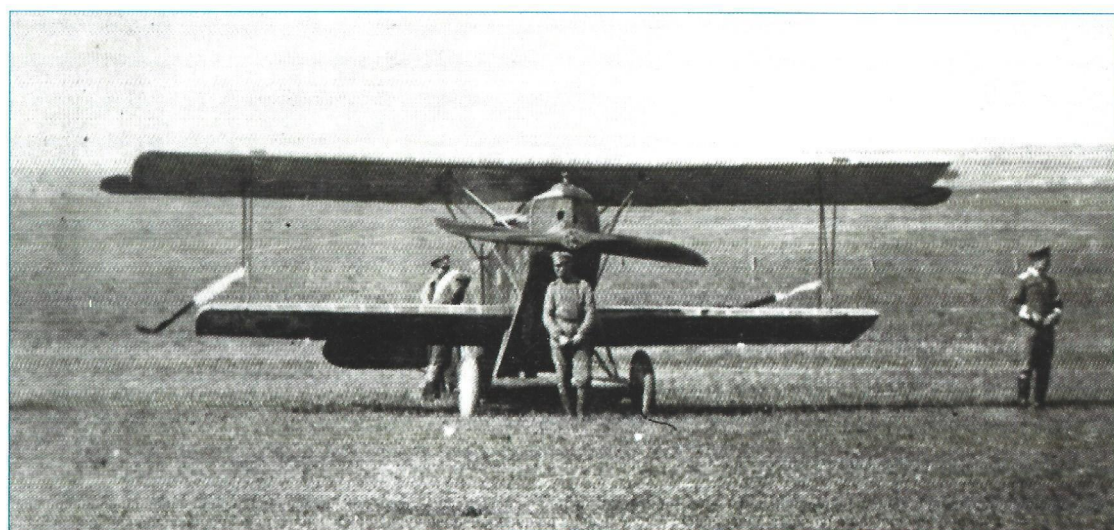
Front view of a Fokker D.VII, seen in 1919, with coloured pennants attached to its outer wing struts, before a public display flight. Notice the barely seen cockade on the wing under surface.

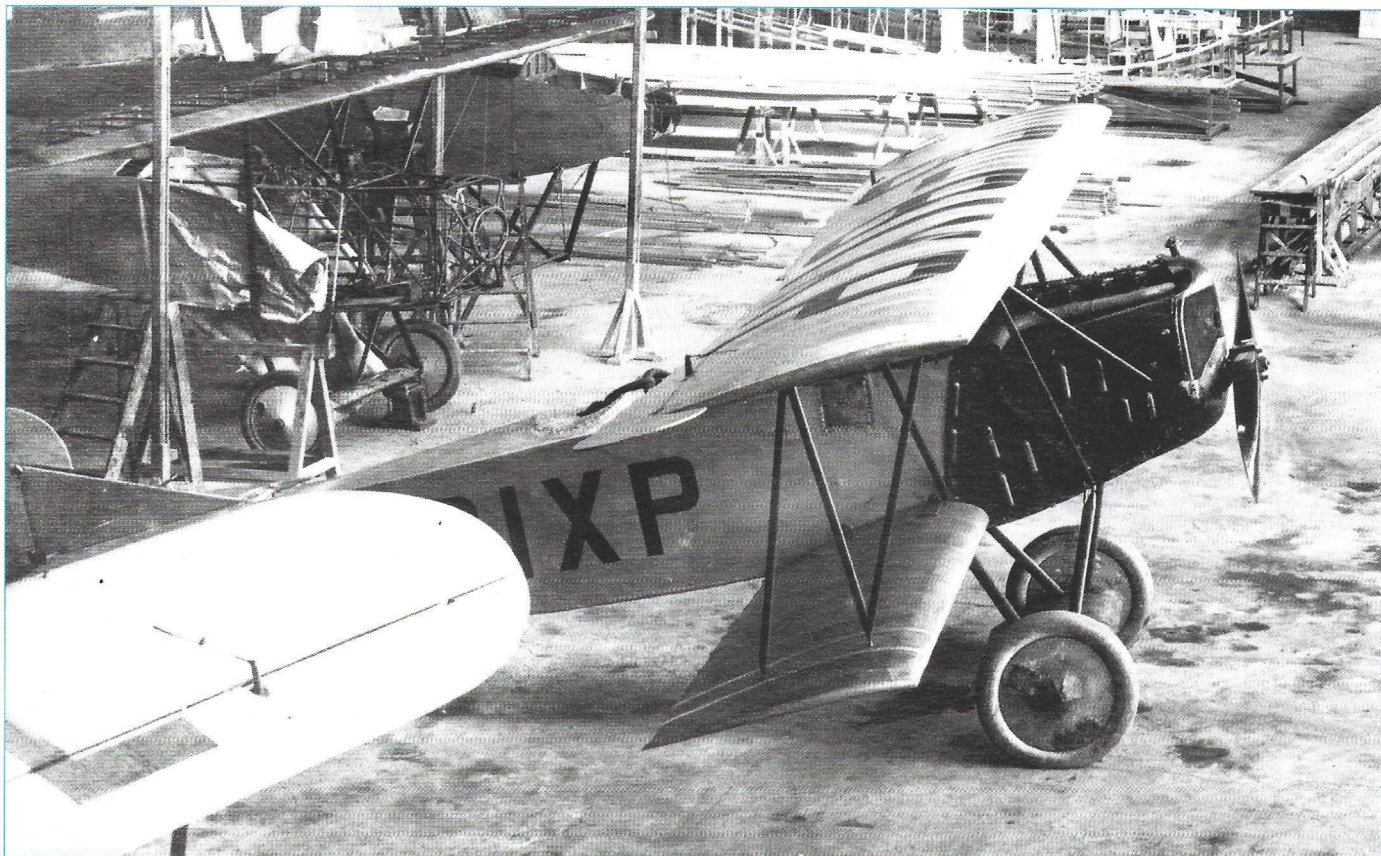
Later on, after Bulgaria was officially allocated civilian aviation registration letters in June 1923, the Fokker was identified as B-BIXP, applied in black on the fuselage and both wing surfaces, directly over the airframe's crème colour. Notice the covered dummy rear cockpit, which was intended to disguise the single-seat fighter as a two-seat trainer.

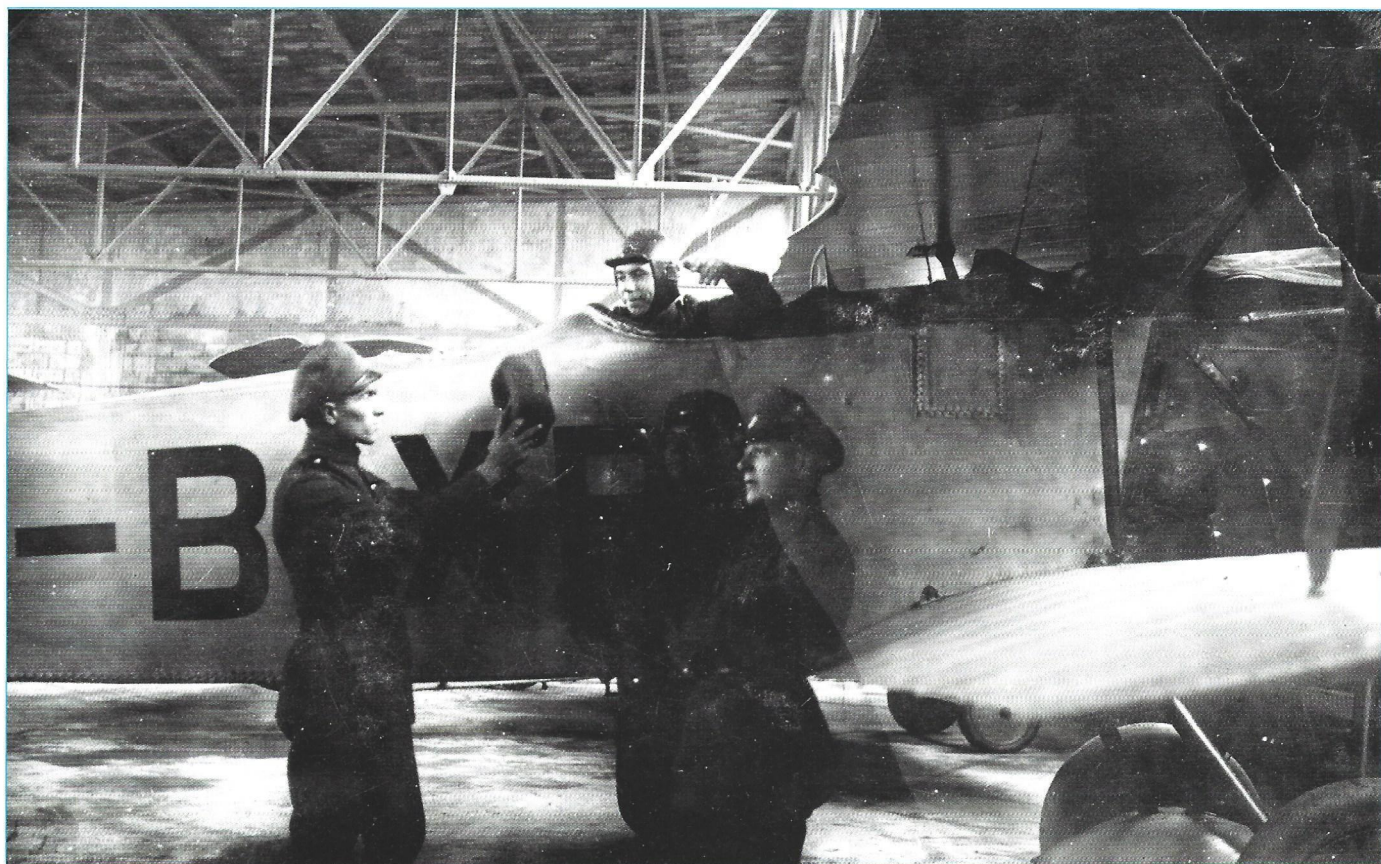
Soon after, the black civilian registration was applied over a black bordered white rectangle (on the fuselage only). The civilian marked fighter, based at the main military airport of Bozhurishte, was "occasionally" fitted with a pair of machine guns and sent to intercept intruding foreign aircraft, which flew with impunity over Bulgarian skies. It was intended to be a message that Bulgaria was not "a house without dog" – as a veteran pilot aptly put it. Depicted is B-BIXP in its element, flying in the vicinity of Bozhurishte base airfield, in 1926 (as identified by the writing on the original negative's top right corner).

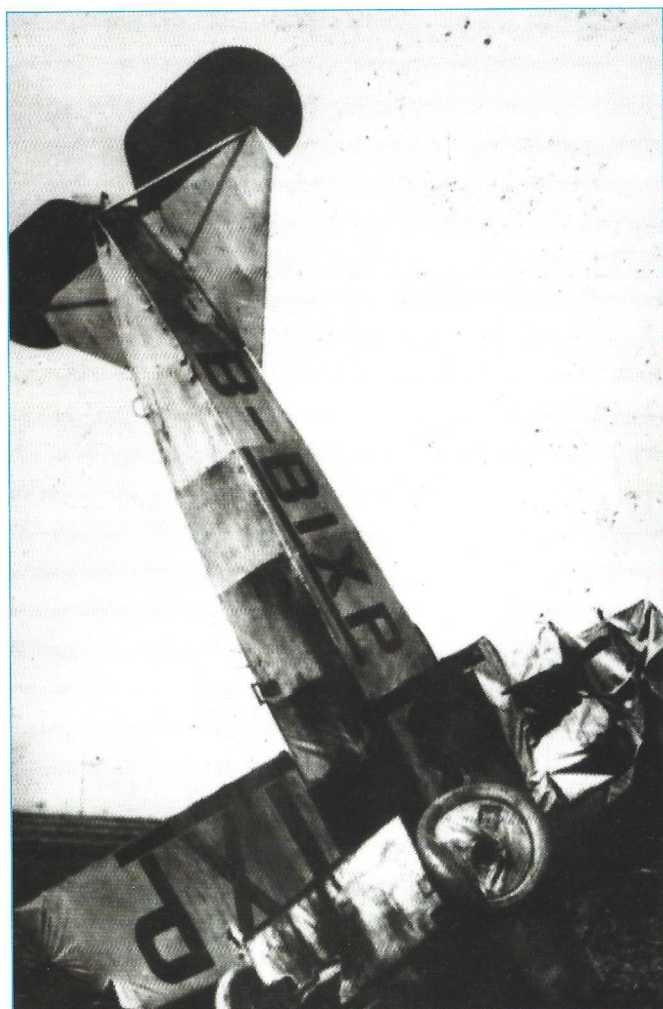
Left: The sad remains of the crashed Fokker D.VII signal the end of the lacklustre decade-long career of Bulgaria's sole post-war fighter aircraft, which lasted from November 1918 until January 1928. At the time of its demise at the hands of Por. Kokilev, the black civilian registration was applied directly onto the airframe's crème base colour.

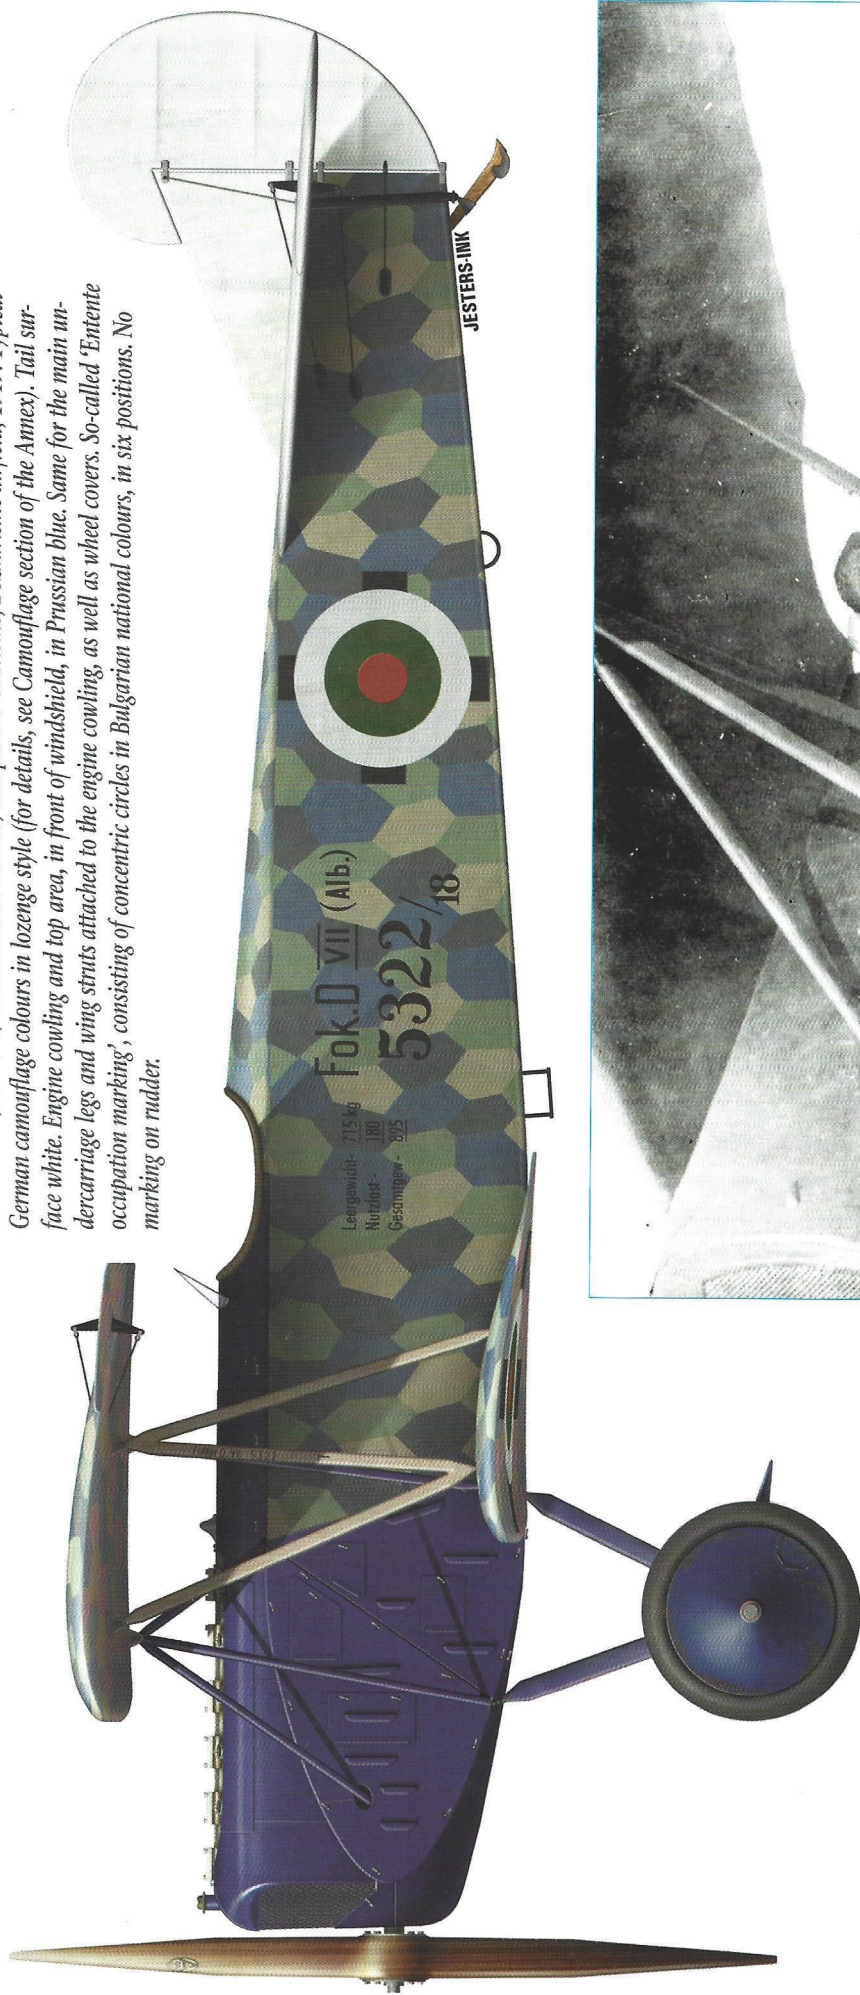
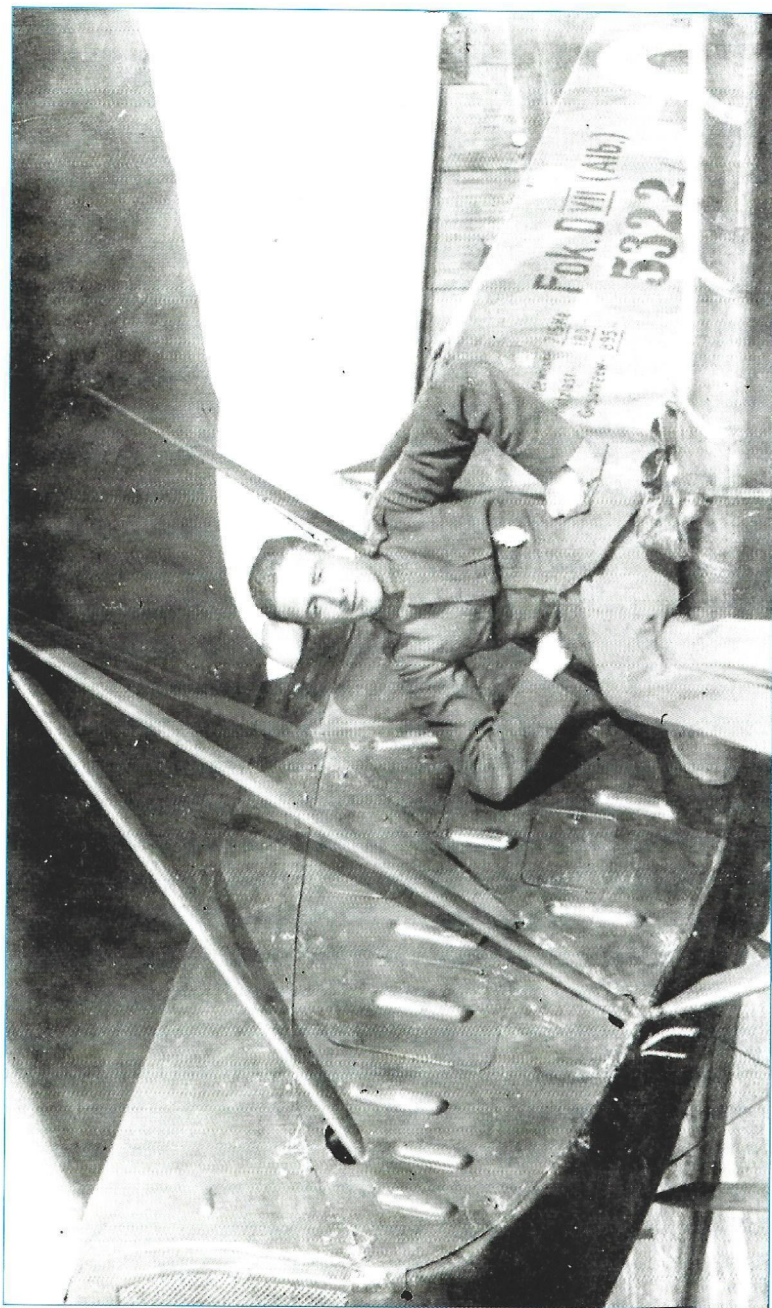
Fokker D.VII, 5322/18, Poruchik Ivan Kärstev, Aeroplanno Otdelenie, Bozhurishite airfield, 1919. Typical German camouflage colours in lozenge style (for details, see Camouflage section of the Annex). Tail surface white. Engine cowling and top area, in front of windshield, in Prussian blue. Same for the main undercarriage legs and wing struts attached to the engine cowling, as well as wheel covers. So-called 'Entente occupation marking', consisting of concentric circles in Bulgarian national colours, in six positions. No marking on rudder.

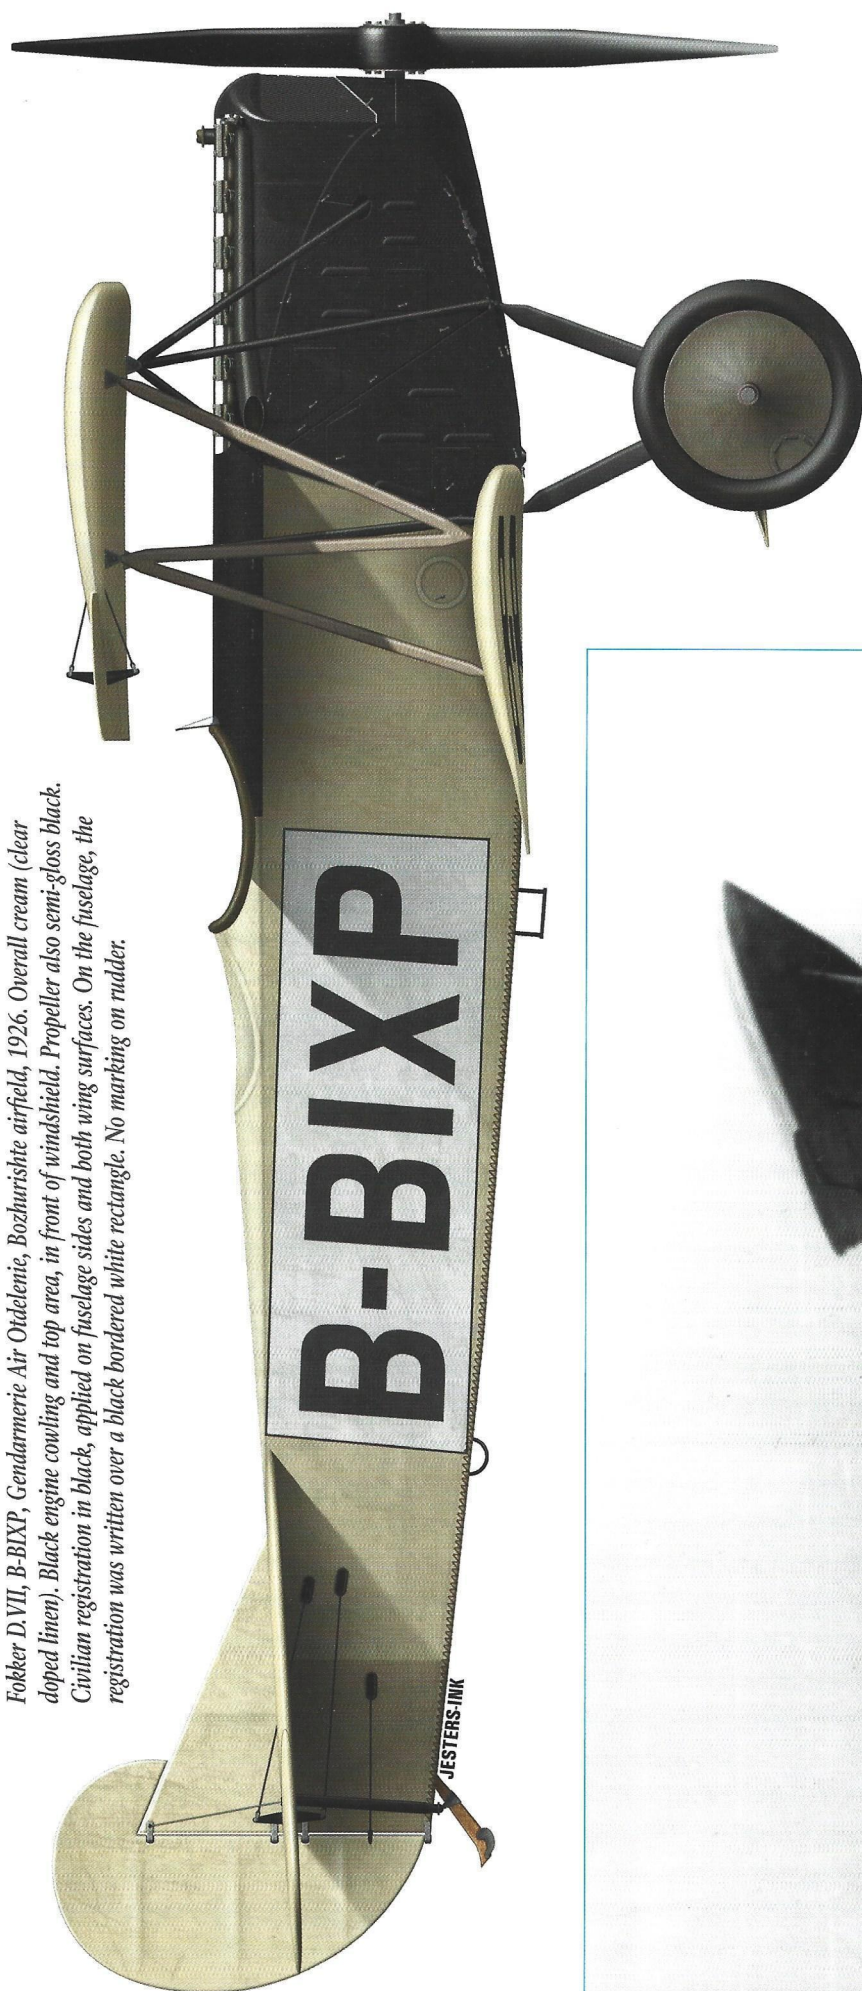
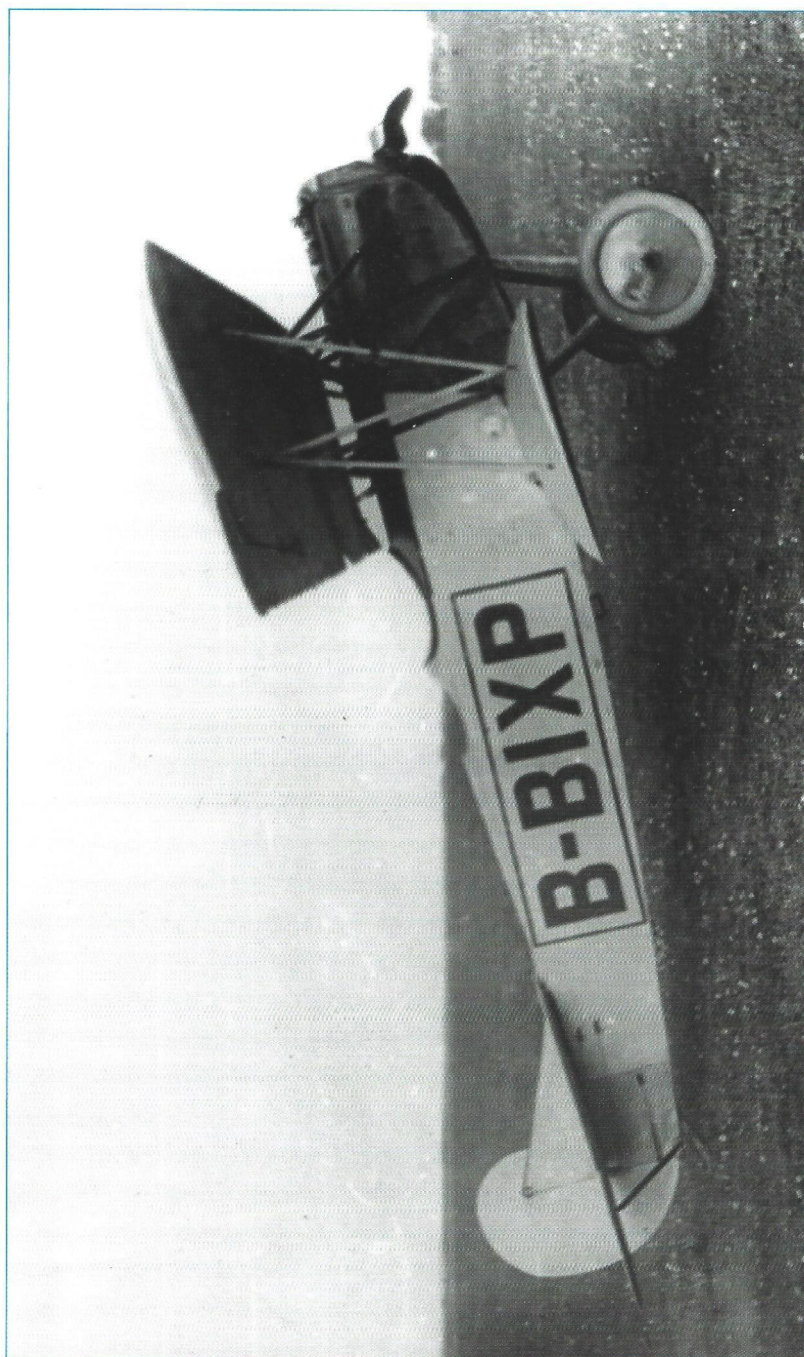
Fokker D.VII, B-BIXP, Gendarmerie Air Otdelemie, Bozhurishite airfield, 1926. Overall cream (clear doped linen). Black engine cowl and top area, in front of windshield. Propeller also semi-gloss black. Civilian registration in black, applied on fuselage sides and both wing surfaces. On the fuselage, the registration was written over a black bordered white rectangle. No marking on rudder.
